## Appendix D: Northeast C1217

### Field Notes and Pictures

Utility: ComEd      Investigators: J. Stutsman & J. Spencer

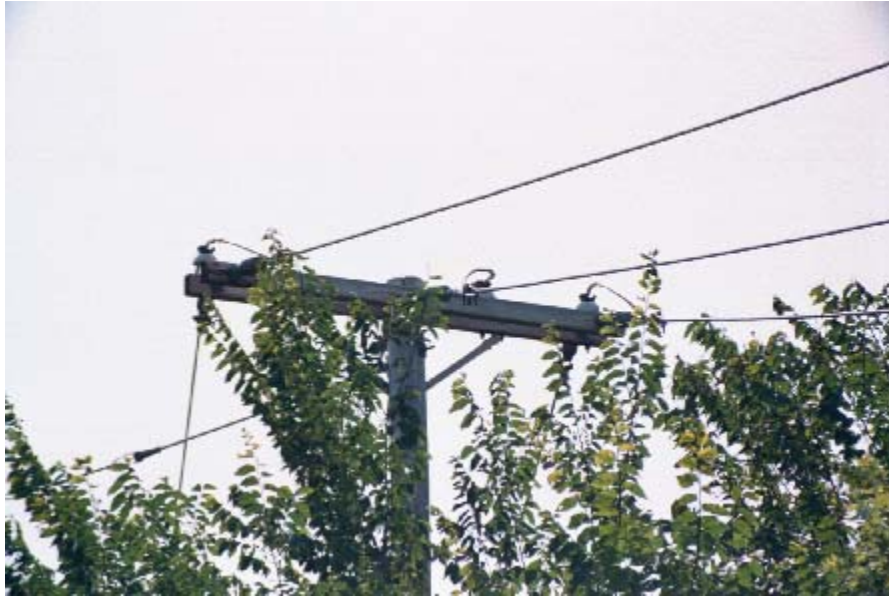
Picture D1

Contact with bare primary near intersection of Greenbay Rd and Vernon Av in Glencoe

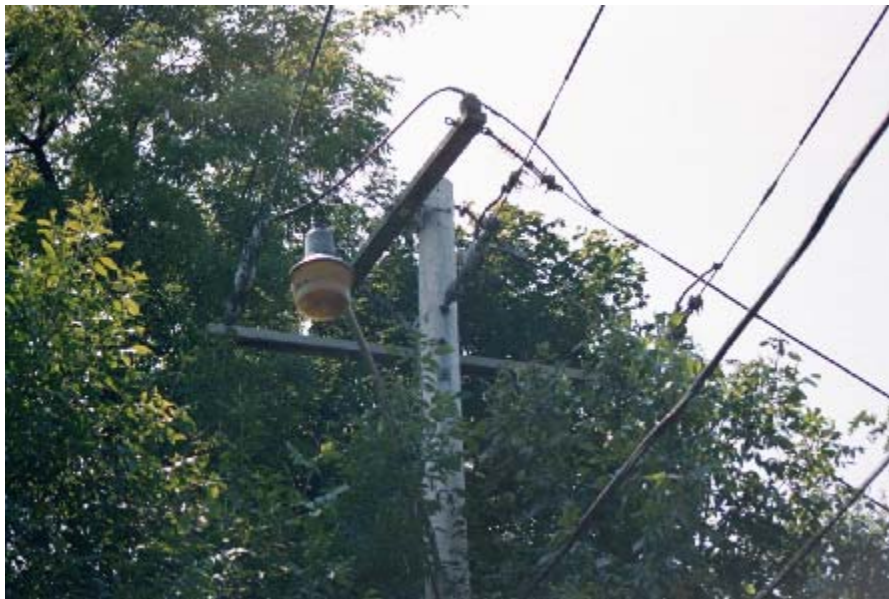
Picture D2

Contact with bare hardware and insulated primary in tree on Meadow Rd near Rail Rd in Glencoe

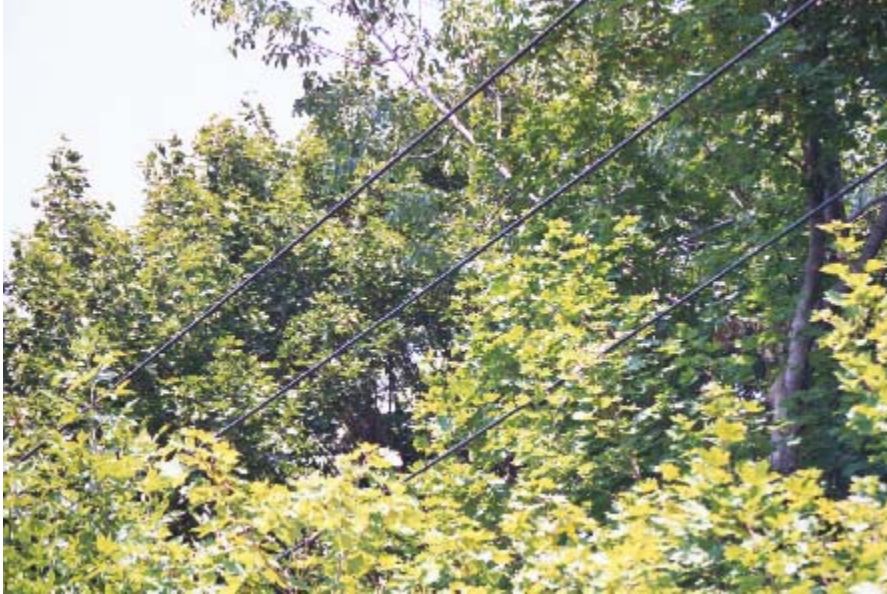
**Picture D3**

**Insulated primary (tree wire) seen going into trees along Sylvan Rd west of intersection with Franklin Rd in Glencoe**

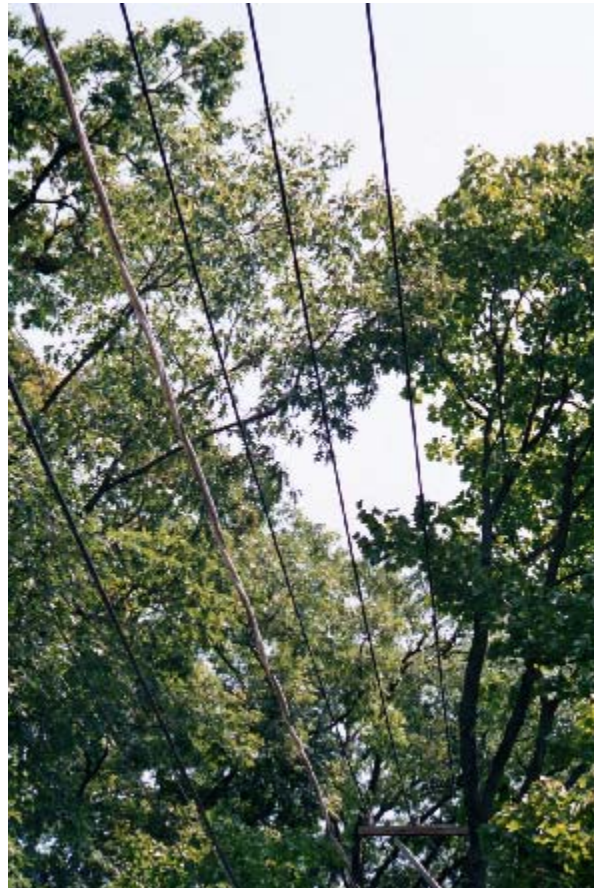
**Picture D4**

**Example of trees overhanging primary -- typical in Glencoe and Highland Park areas**

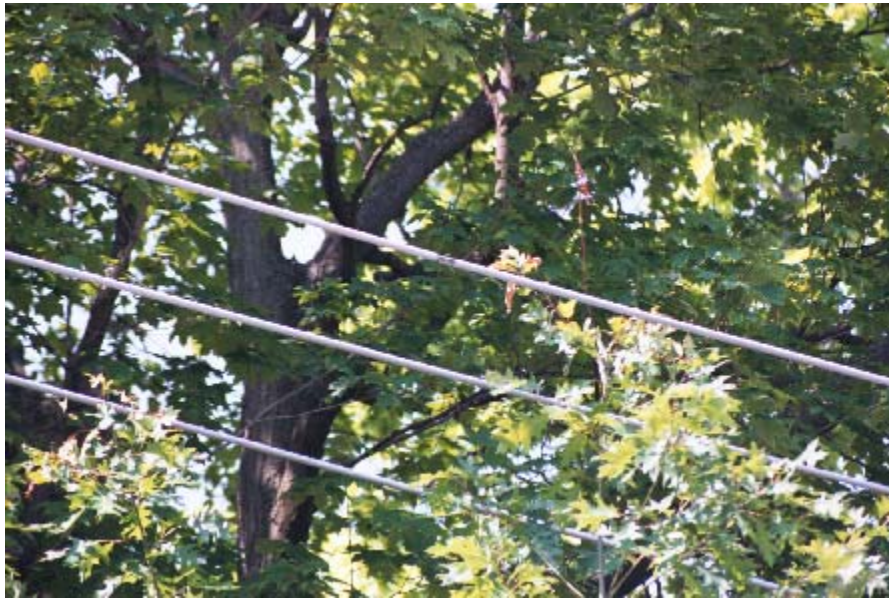
### Picture D5

Tree has grown into primary with burning visible on branches. Burnt insulation is visible on street side wire. Located at intersection of Brentwood and Sheridan Rd. in Glencoe.

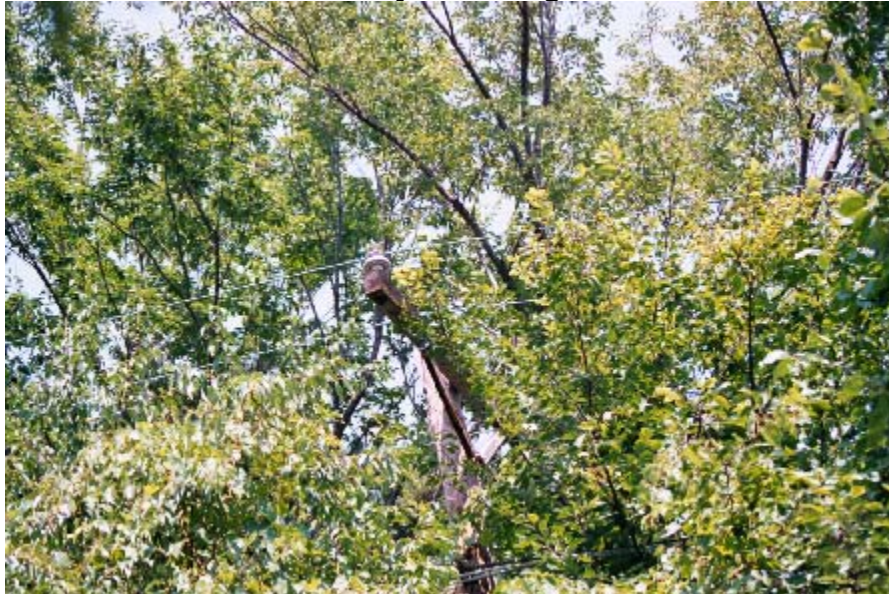
### Picture D6

Tree into cross arm and primary contact with burning near intersection of Clavey and Greenbarry Rd in Highland Park

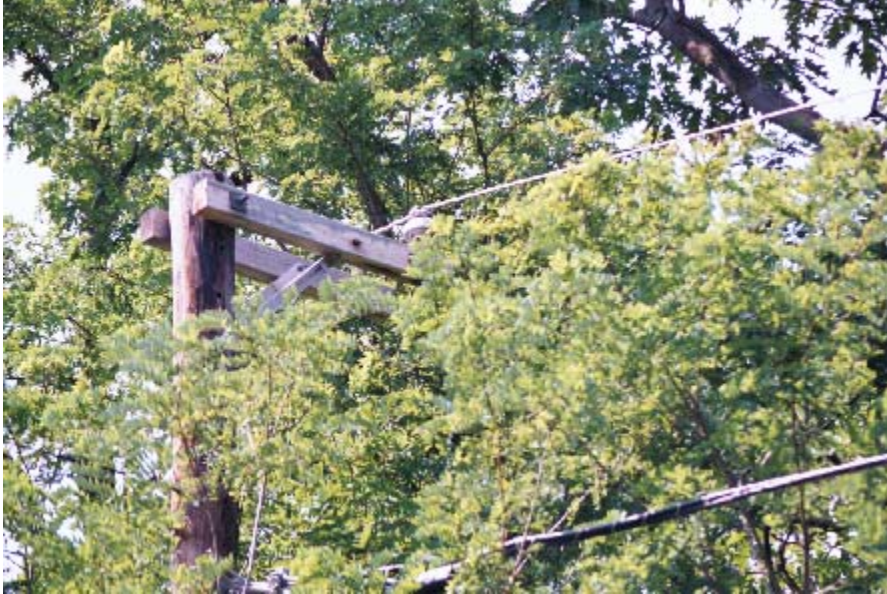
Picture D7

Locust tree contact with bare wire on both sides of pole with burning located near intersection of Oakland Dr. and St. Johns Ave. in Highland Park

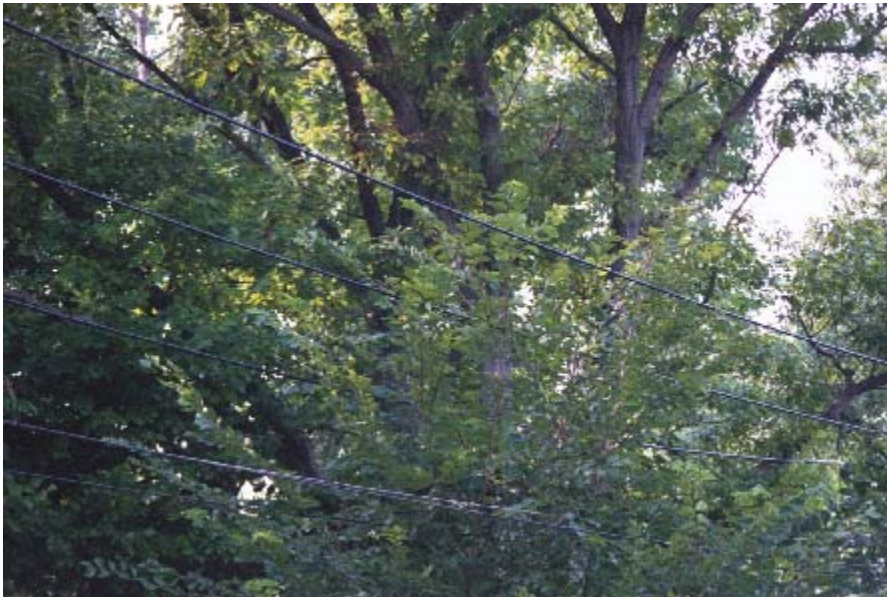
Picture D8

Tree has grown up between phases of primary at 1491 St. Johns Ave. in Highland Park
